Overlay of Large, Placed Quarystone and Boulders to Increase Riprap Stability

Bruce L. McCartney and John P. Ahrens

TECHNICAL PAPER NO. 76-19
DECEMBER 1976

U.S. ARMY, CORPS OF ENGINEERS
COASTAL ENGINEERING
RESEARCH CENTER

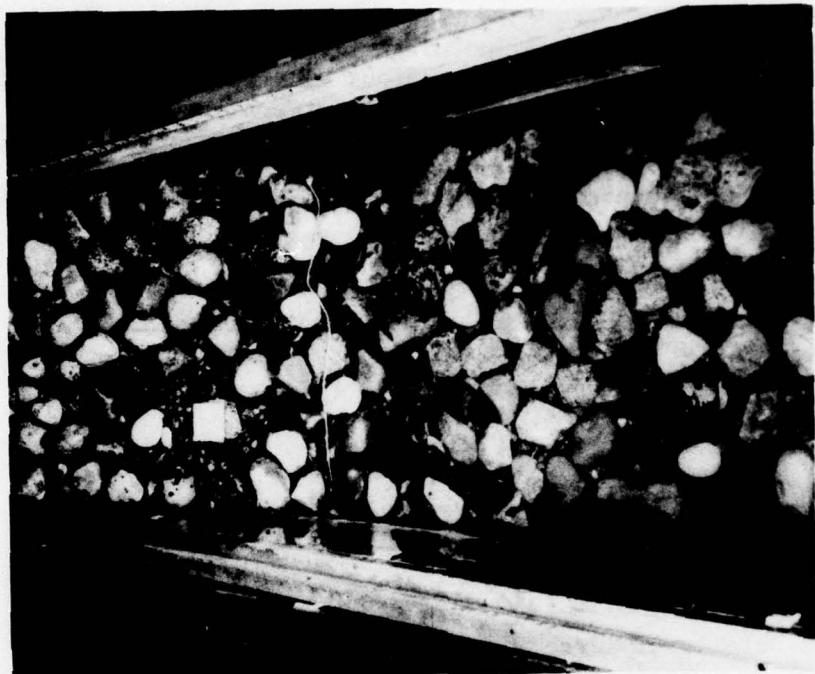
Figure 4. Small wave tank test of 67-percent stone overlay (boulders).

Slope failure, $H_g = 0.325$ ft;
1.5- to 2-in scale boulders

Initial condition,
rope denotes stillwater level;
tank 1.5 ft wide;
1.5- to 2-in scale boulders

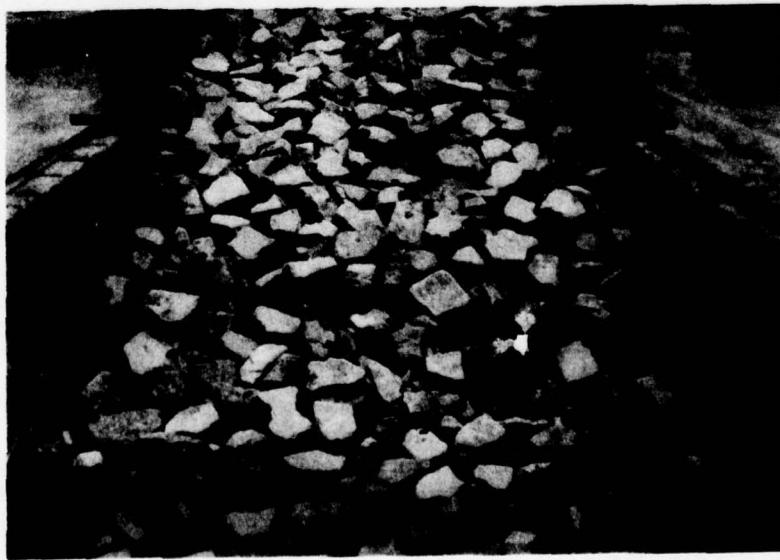
Figure 6. Prototype tests of 100-percent stone overlay (quarrystone) coverage.

The large wave tank testing at prototype scale was done to determine what corrections were needed for the small-scale test results to make the small tank test representative of prototype conditions; i.e., determine scale effects. Large tank test photos of the 100-percent quarrystone overlay ($W_{50} = 100$ pounds) are shown in Figure 6.

Initial condition
